VII. PHYSICAL PLANT INVENTORY

FACILITY INVENTORY AND INSPECTION PROGRAM

Carolina Beach State Park Buildings In Use

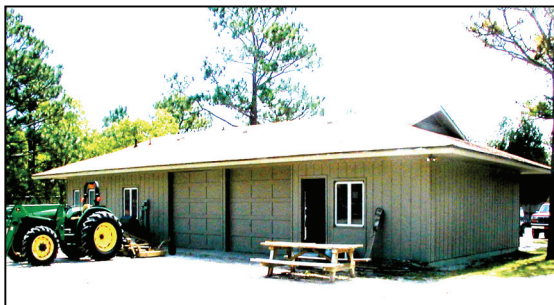
Figure I-1. Maintenance Office and Shop

- Maintenance Office & Shop: Built in 1971. 1,706 SF wood frame building used as maintenance office and shop. Formerly used as park office/maintenance building. Good condition. (Figure I-1)

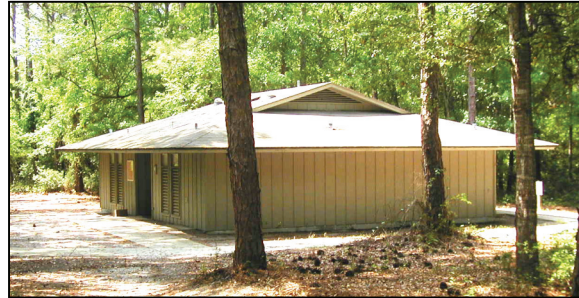
Figure VII-2. Campground Washhouse

- Public Toilet Building: Built in 1971. Heated wood-frame building used for public toilets. Located in the picnic area. Good condition.
- Washhouse, Campground Loop 1: Built in 1971. 830 SF heated concrete block building with wood siding, used as a washhouse. The washhouse is currently being remodeled to meet ADA guidelines.

- Washhouse, Campground Loop 2: Built in 1971. 830 SF heated concrete block building with wood siding, used as washhouse. The washhouse is currently being remodeled to meet ADA guidelines.

Buildings and structures at Carolina Beach State Park are in good condition considering their location in a harsh coastal environment. They are being adequately maintained. Staff currently has a contract underway to make both washhouses and the picnic area restrooms ADA compliant. Other needed maintenance and repairs are ongoing.

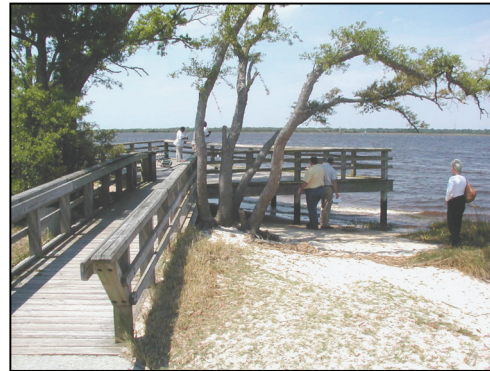
Figure VII-3. Fishing Pier

- Marina Basin: Last dredged in 1999. Dredging is expected approximately every 7-10 years. Depth is currently a problem.
- Fishing Pier: Built in 1996. Handicapped accessible, pressure treated wood structure on six-inch pilings. Occasions of high water have caused the pier to float upwards in some areas, causing an unlevel surface, but the pier remains operationally sound (Figure VII-3).
